PRESERVATION ASSESSMENT AND PLAN FOR THE OLD ATHENS CEMETERY, ATHENS, GEORGIA

Prepared By:
Michael Trinkley, Ph.D.
and
Debi Hacker

CHICORA RESEARCH CONTRIBUTION 459

December 22, 2006

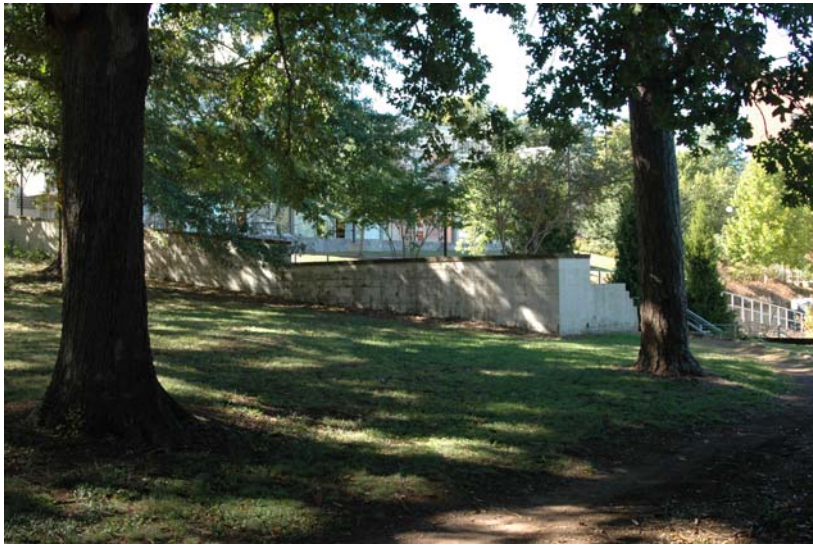
Today the peace and tranquility of the cemetery is compromised by its location adjacent to Jackson Street and the heavy use of this artery for mass transit. The vista to the east has been protected by the historic lowering of Thomas Street. Given the scale and setting of Baldwin Hall to the south, the vista in this direction is not objectionable. To the north, however, the construction of the art school and parking garage have created very discordant and intrusive settings (Figure 6). This is further aggravated by the CMU wall along the northern boundary of the cemetery (Figure 7). This wall is entirely out of context and is too low to offer any

Figure 7. CMU wall along the northern cemetery boundary. This wall is out of character and intrudes into the cemetery landscape.

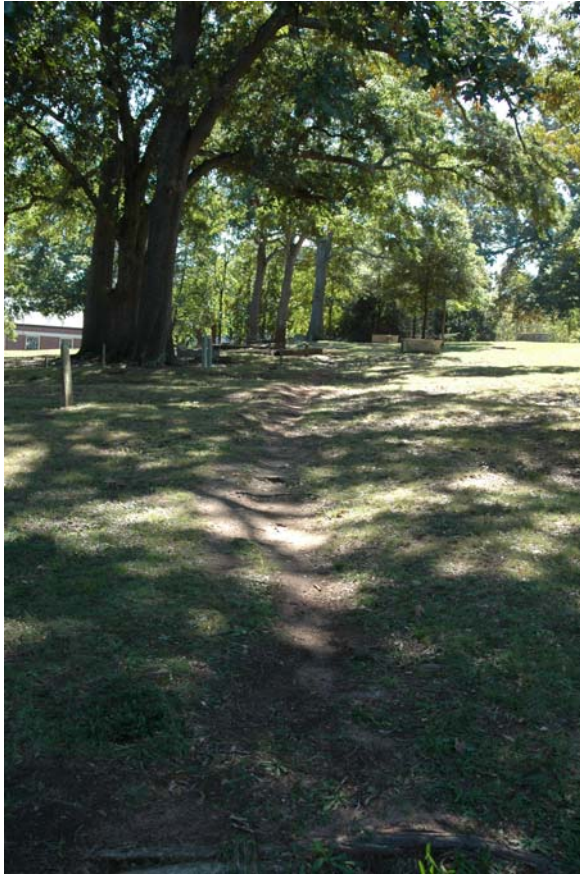
Figure 16. Western pathway showing erosion (top) and tomb exposed in path (bottom).

The eastern pathway, because it is in an area of reduced slope and the ground is likely more compact from previous use, requires less attention. In this area we recommend that the pathway be infilled with mulch. This would maintain the soft appearance of the pathway and minimize long-term maintenance costs. We estimate that this work would cost approximately \$2,100.

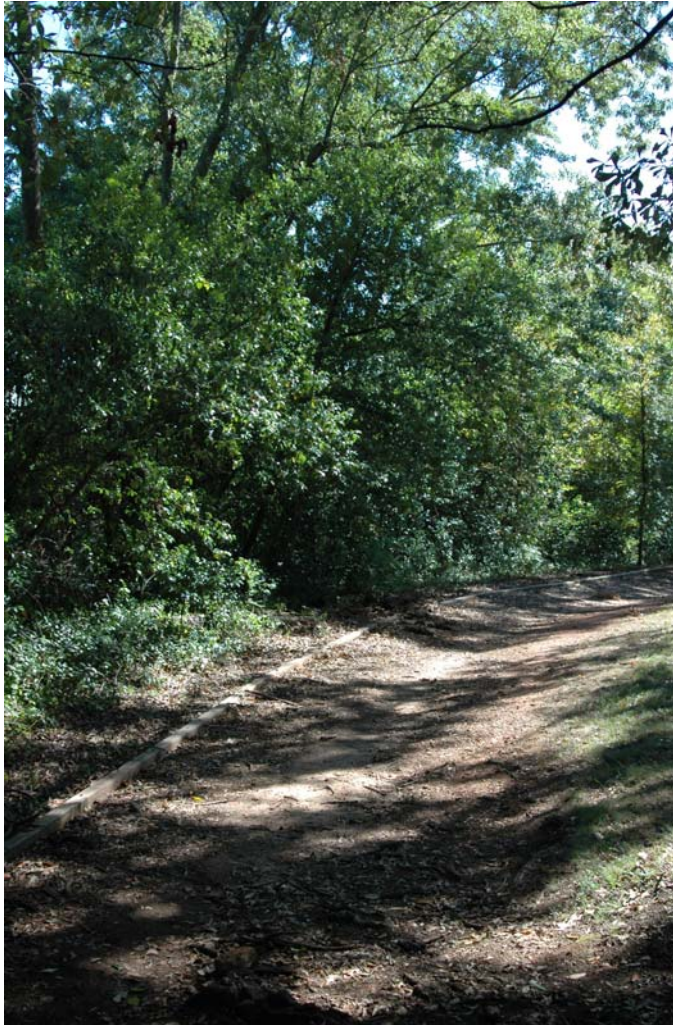
Figure 17. Path at eastern edge of the cemetery.

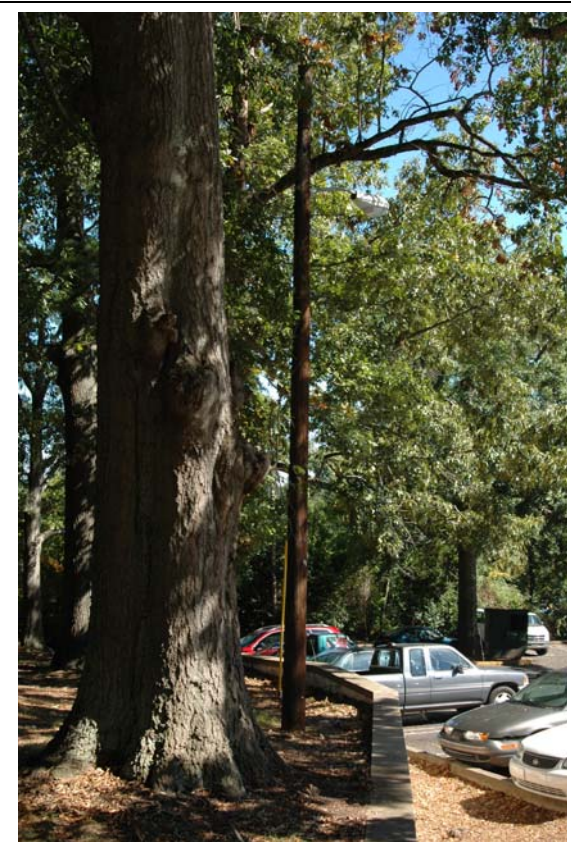
Figure 18. One of two utility pole "street lamps" at Baldwin Hall. The University should immediately install additional lighting in the cemetery.

The only lighting that is present comes from two wood utility poles with High pressure sodium vapor lamps directed into the Baldwin

Additional lighting should be added to the cemetery, focusing on the two pathways and Jackson Street. The anticipated cost is approximately \$9,000.

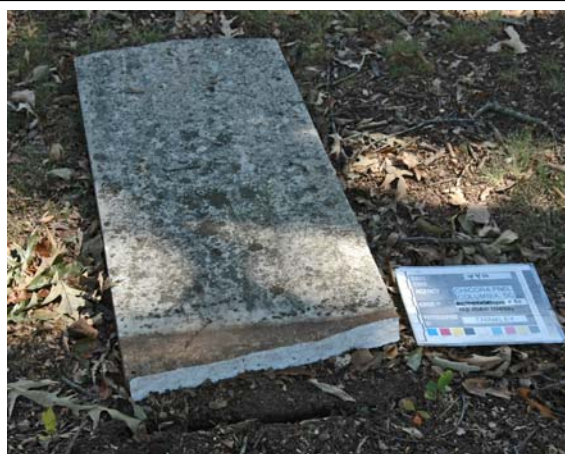
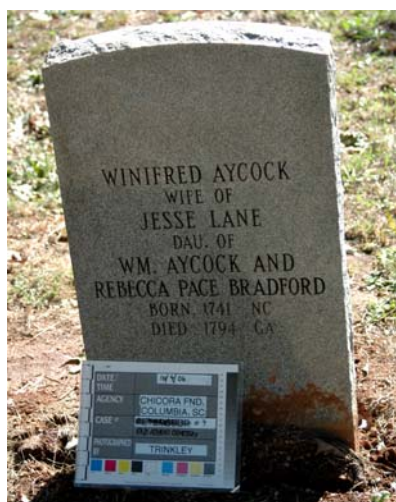
Figure 19. Examples of vandalized stones. The top stone has been broken off at ground level; the bottom stone was uprooted and kicked over.

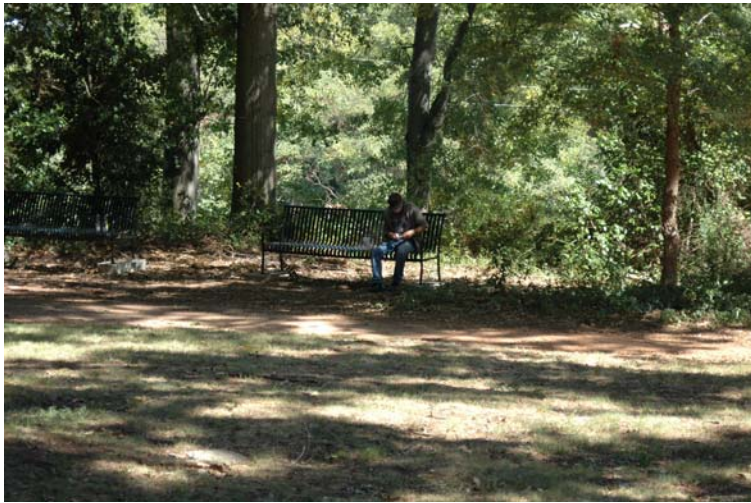
Figure 20. Homeless use of the cemetery can discourage legitimate use.

Police and Staff Patrols. Previously discussed under “Rule Enforcement,” it is critical that the University have a much higher visibility in the cemetery than is currently the case. During our two-day assessment we failed to see a campus or city police officer or any maintenance in the cemetery or even in close proximity. In spite of the heavy litter in the cemetery, the litter patrol individual covered only the concrete sidewalk on Jackson Street and along the edge of the Art Building. This must change – there must be a much higher degree of police and staff visibility in the cemetery.

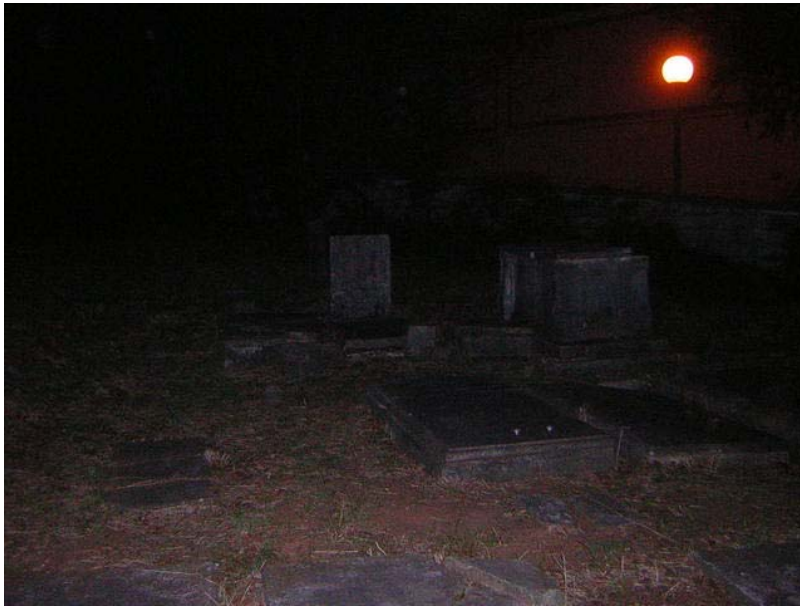
Figure 21. Photograph taken by a paranormal investigator in the Old Athens Cemetery about 9:00pm. Note the limited light from the Art School lamps; even the photograph flash provided only limited lighting. This photo also shows several candles on a ledger.

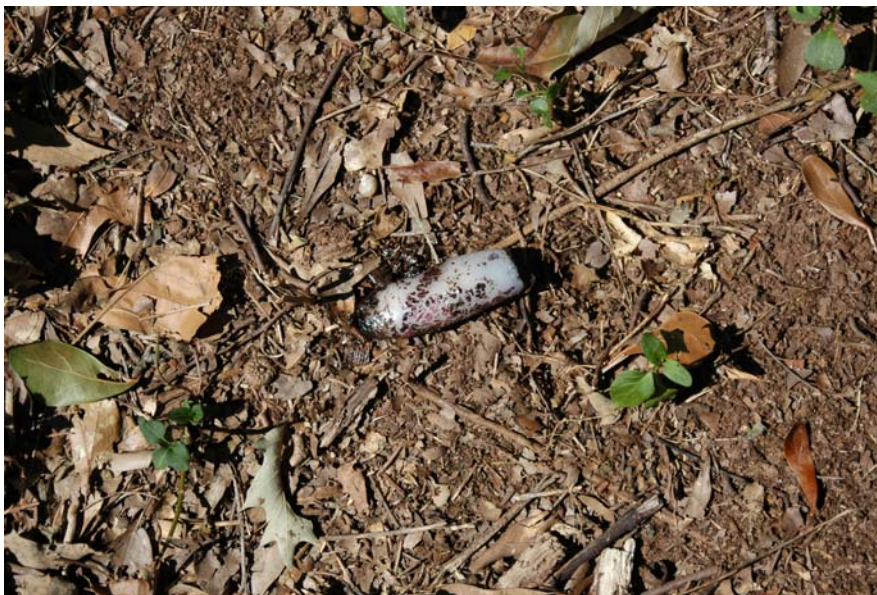
Figure 22. Discarded candle in the cemetery.

The University should develop an integrated vandalism reduction policy for the cemetery. Minimal components should include, in addition to lighting, publicity education, and aggressive enforcement. It is critical that police patrols be implemented, with additional surveillance during holidays, weekends, and in-town football games.

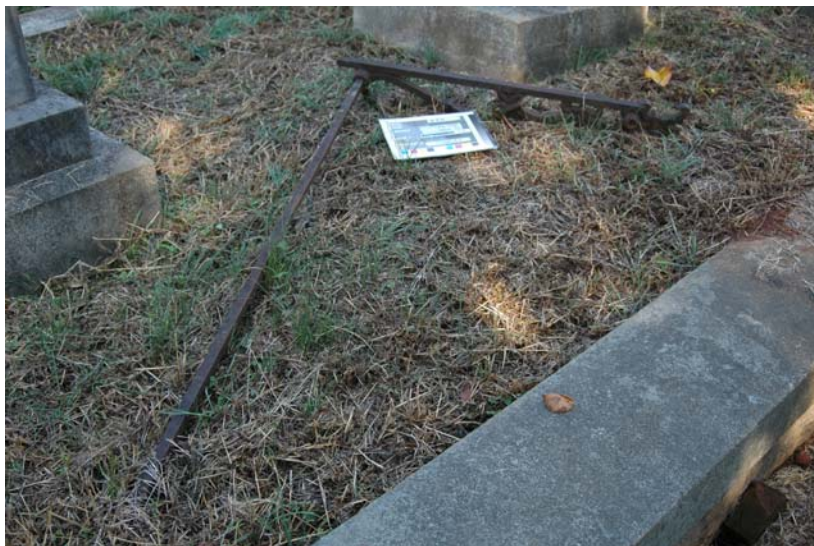
These fences, however, are in various states of deterioration and all require immediate attention. Sections are missing, posts are broken or are no longer solidly set, finials are broken or missing, supports are no longer stable, and there is much corrosion. Details of each fence are included in Appendix 2 (plots 3, 6, 11, 37, 44,

Figure 23. Fence parts should not be allowed to lie in or around plots, but should be collected and secured.

and 58) and these treatment proposals should be consulted for specific information.

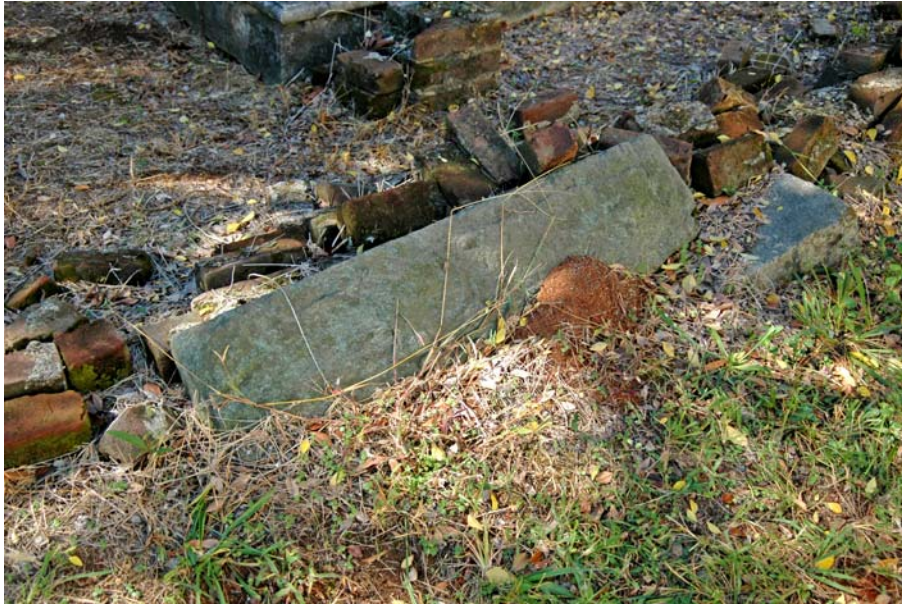
Figure 24. Crumbling plot wall. The brick wall has almost entirely collapsed and this is the only stone cap that hasn't been stolen.

About an equal number of plots have brick or granite curbing. These, too, are in a generally dilapidated condition (Figured 24).

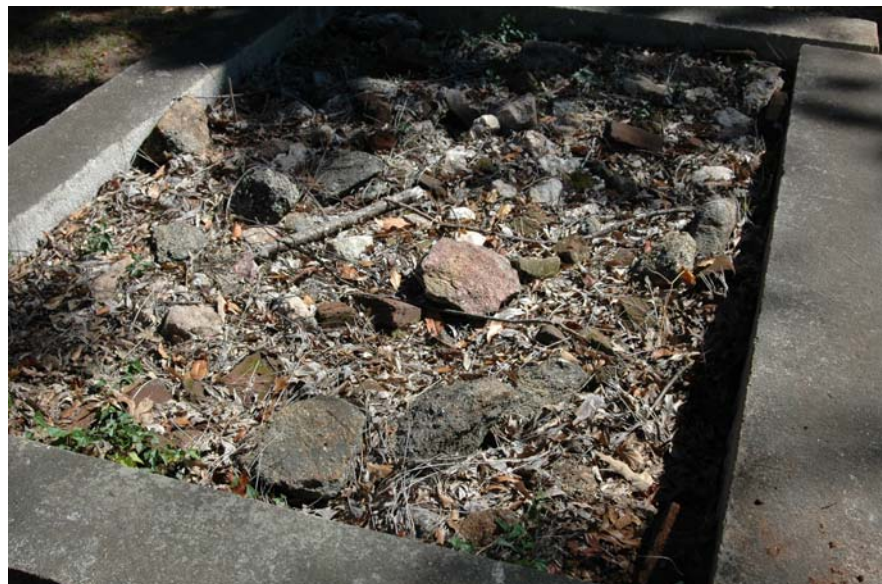
Figure 25. Plot interior filled with debris.

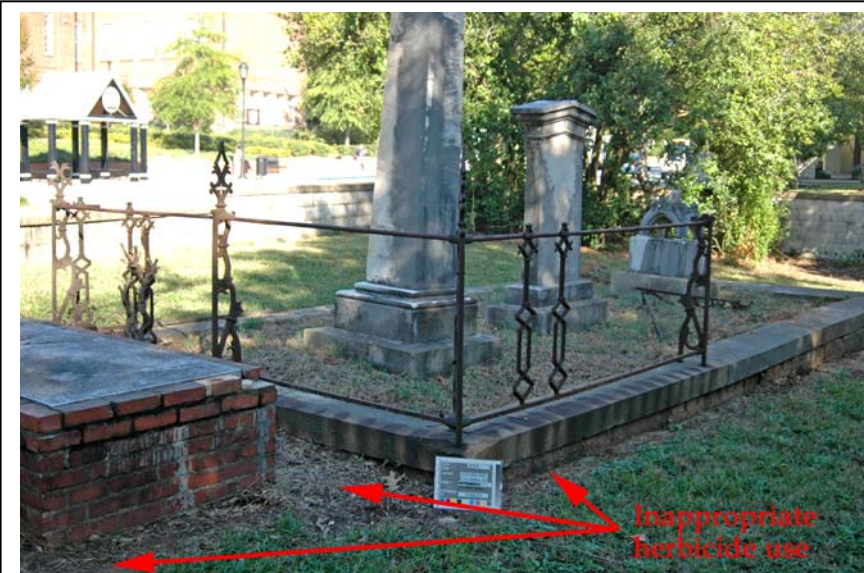
Figure 26. Herbicide use around edges of walls and tombs. This disfigures the landscape and is inappropriate in cemeteries.

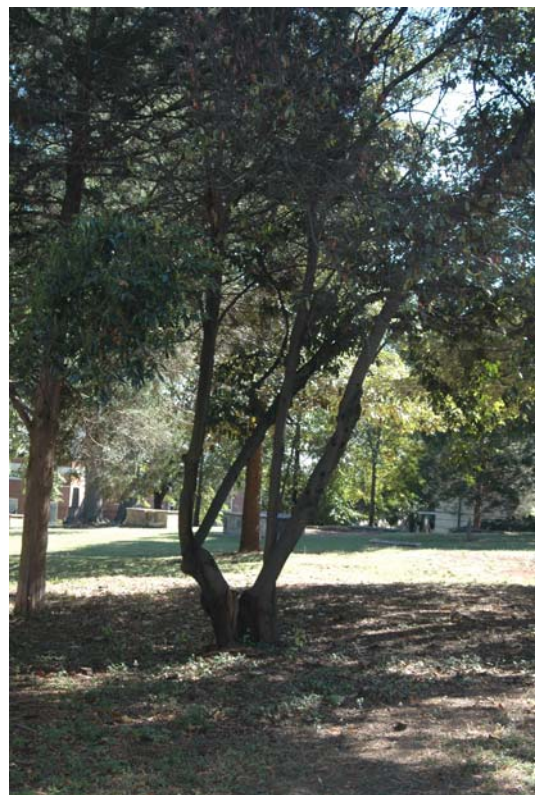
Figure 27. Diseased cherry laurel that should be removed from the cemetery. Adjacent stumps should also be cut off at ground level. All stumps should be poisoned to prevent suckers.

Not included on this list is one specimen of cherry laurel, most of which has been removed. We strongly recommend that the remainder of this

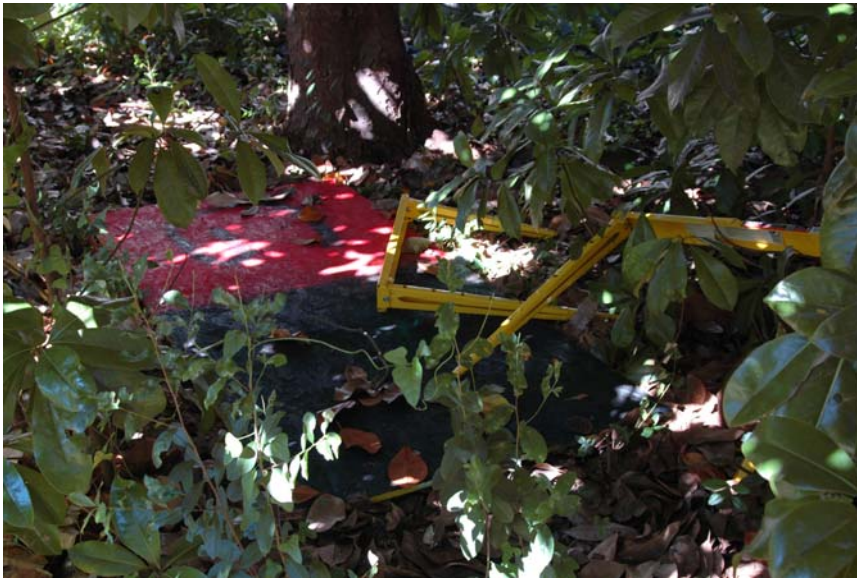
Figure 28. Debris hidden under the magnolia in the cemetery. We recommend clearance pruning to raise the branches and provide sight lines under the tree.

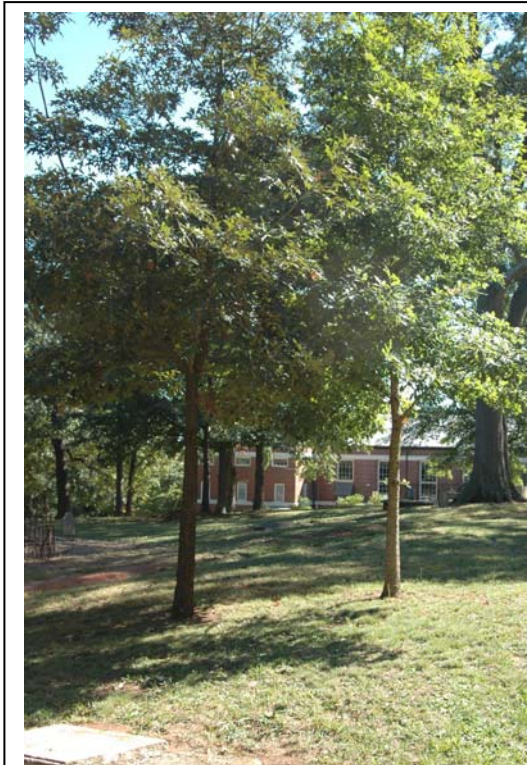
that were inexplicably placed in very close proximity to one another. This creates a future problem and one should be removed immediately (Figure 29).

Figure 29. The white oak (right) and red oak (left) have been planted only 12 feet apart. But within 10 years the white oak will spread 10-12 feet and the red oak will spread 12-15 feet. Within 20 years both will spread 12-15 feet. One tree should be removed to provide adequate growing space for the other.

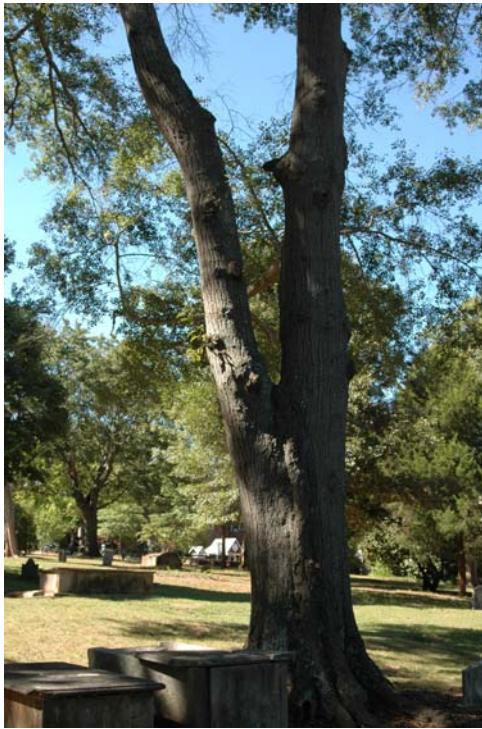
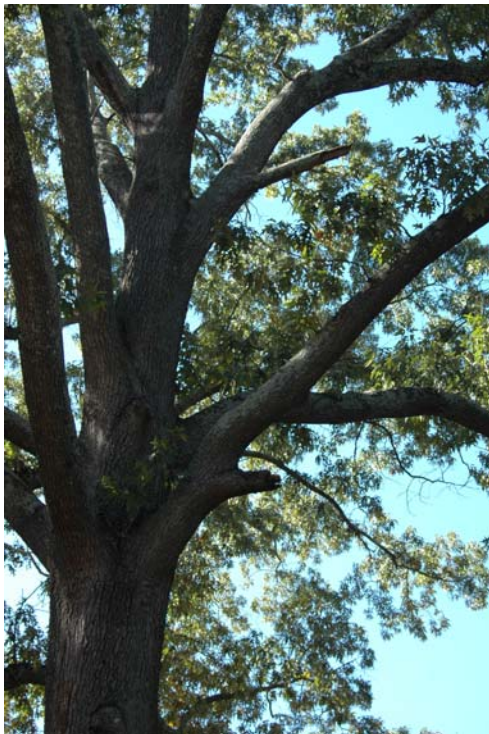
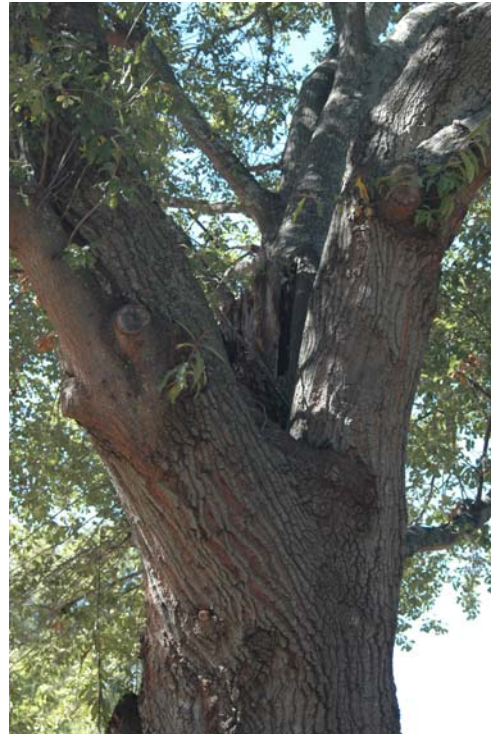
During our visit we observed considerable damage and a number of pruning issues (Figure 30). We observed much dead

Figure 30. Pruning problems. Upper left, weak branch overhanging tombs. Upper right, dead wood that needs to be removed. Lower left, broken limbs. Lower right, damage and disease.

All pruning within the Cemetery should be performed by an International Society of

Arboriculture (ISA) Certified Arborist, preferably one who is also an ISA Certified Tree Worker/Climber Specialist. Table 3 provides a list of Certified Arborists for the Athens area.

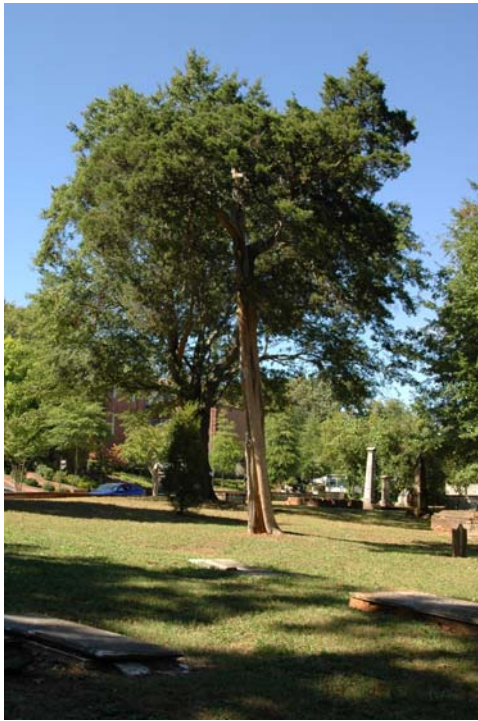
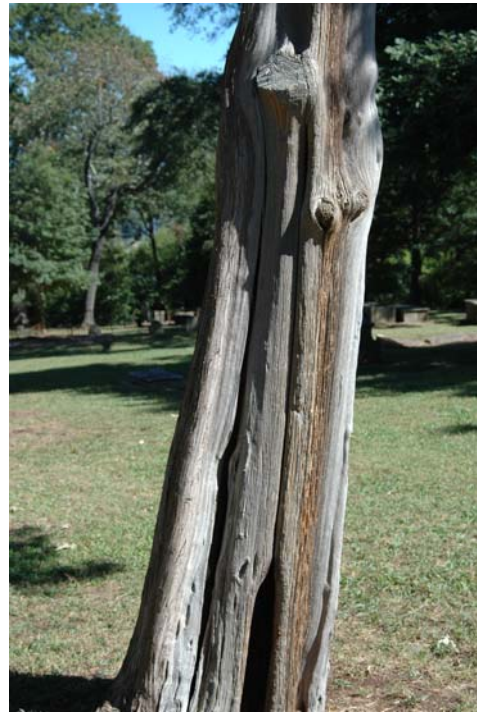
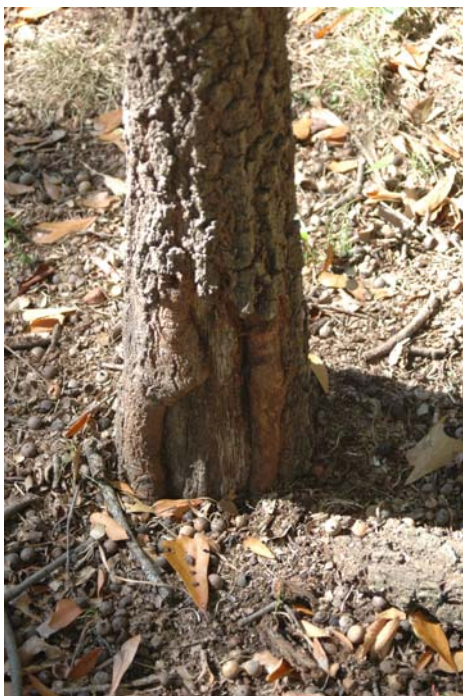
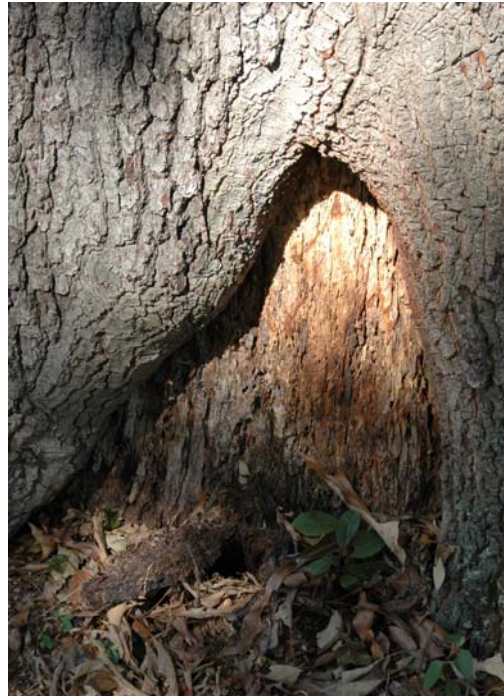
Figure 31. Other tree problems. Upper left, this cedar tree was hit by lightning and topped. Upper right, the tree is cracked and has termites, indicating dead wood. Consideration should be given to removal and replacement. Lower left and right, evidence of old wounds with extensive rot. The extent of damage should be evaluated.

During this visit we observed only limited evidence of pests (such as the termites in the cedar tree shown in Figure 31). Disease was limited to rot (see Figure 31). It is likely that relatively little pesticide has been applied in the past. This is good since many pesticides, because of their salt content, can harm monuments. Where possible Integrated Pest Management practices should be implemented. Where chemical pesticides are necessary, they should be applied as a coarse spray to prevent drift.

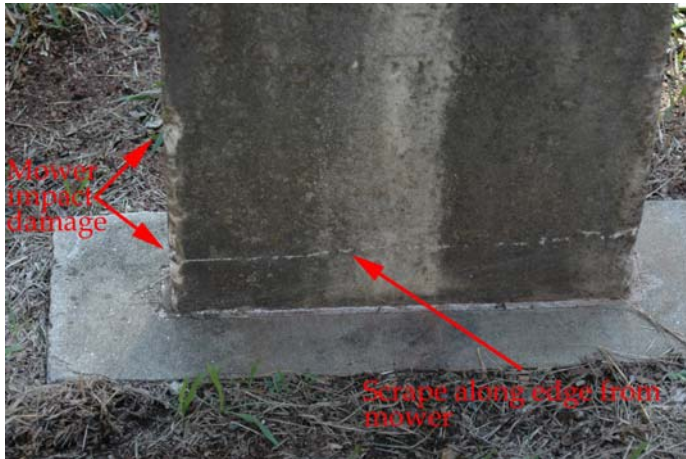
Figure 35. Evidence of mower damage on a stone in the Old Athens Cemetery.

We note that there is abundant evidence of mower damage in the cemetery, although we can’t determine if this has occurred since the University has resumed maintenance or before. Nevertheless, Figure 35 clearly illustrates the potential damage that careless use of mowers can cause to stones.

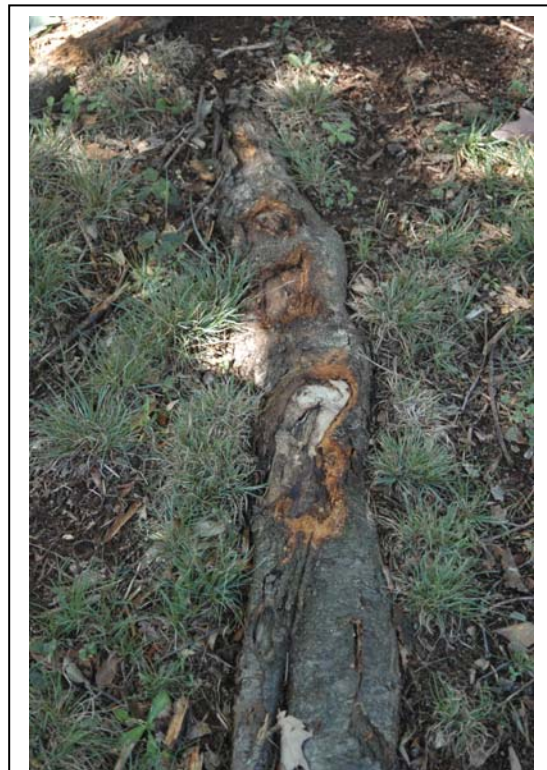
Figure 36 illustrates the damage that is

Figure 36. Extensive mower damage to roots.

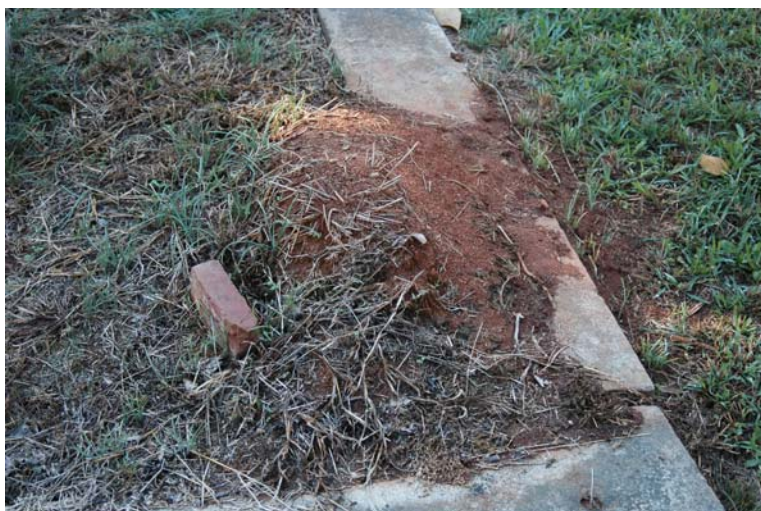
Figure 37. Example of the fire ant problem in the cemetery.

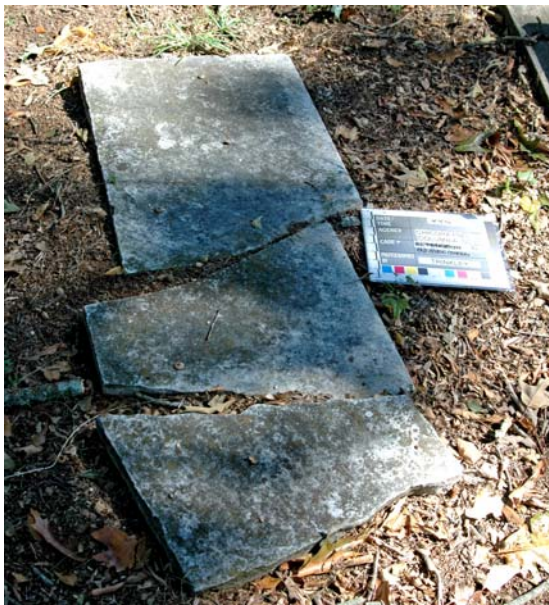
There are displaced stones throughout the cemetery, almost always in plain view. None, however, are being replaced or even being picked up and secured. As a result, stones are being routinely damaged by mowing activities and present an attractive target for

Figure 38. Example of a broken stone. Left loose in the cemetery the stone can be damaged by mowing or pedestrians, or can be stolen.

thieves and souvenir hunters (Figure 38).

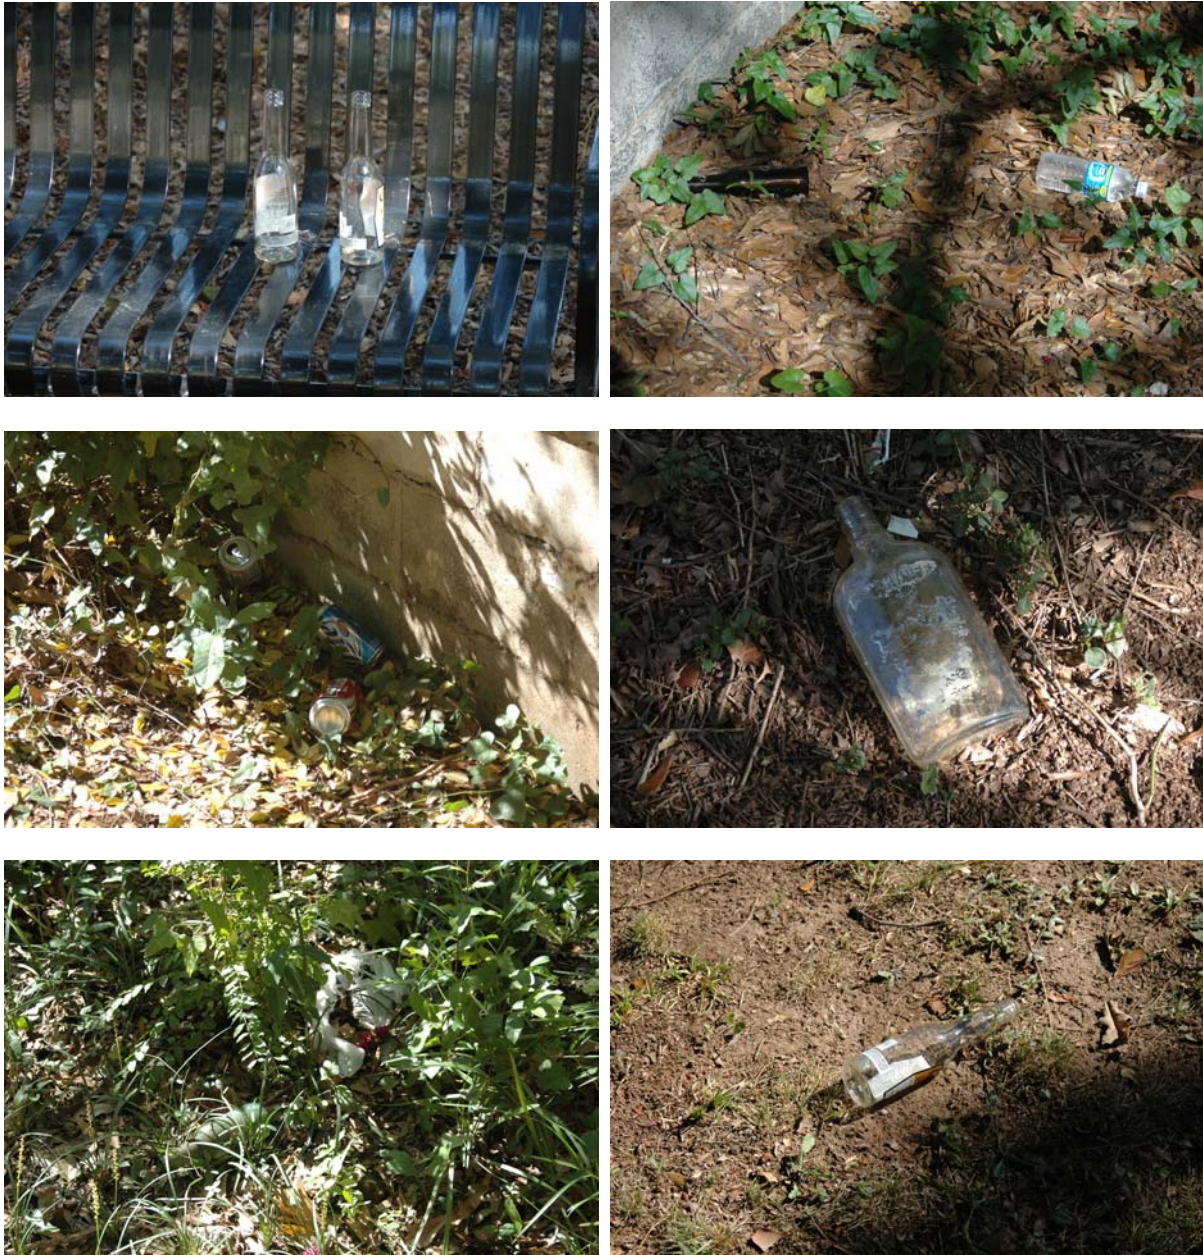
Figure 41. Extensive evidence of trash throughout the cemetery. The University must immediately begin tackling this problem. Allowing trash to remain gives the impression that there is nothing wrong with this practice and only encourages additional trash. Related to the problem of trash is the vandalism that goes along with intoxication. Dealing with the problem involves increasing litter patrols and posting (and enforcing) the ban against alcohol in the cemetery.

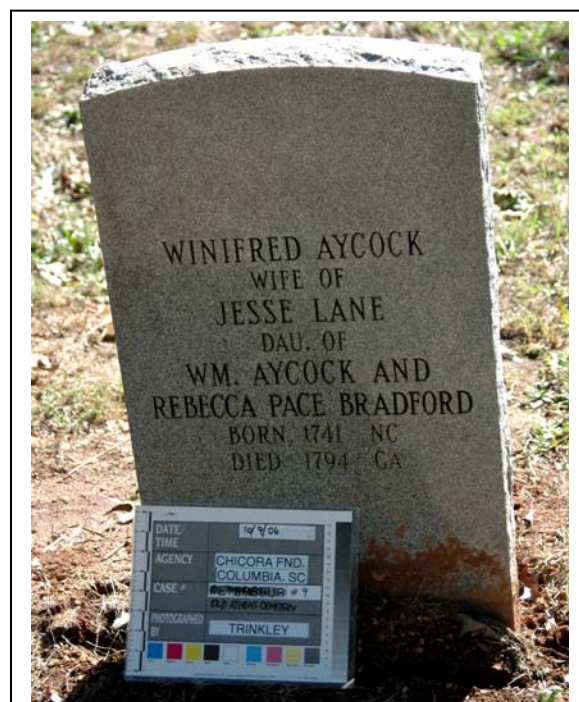
We see several modern stones that have been placed in the cemetery, apparently by descendants. We are told that these stones, on at least one occasion, caused considerable

Figure 42. While the scale and massing of this modern marker are acceptable, the use of granite is not. In addition, its placement is undocumented.

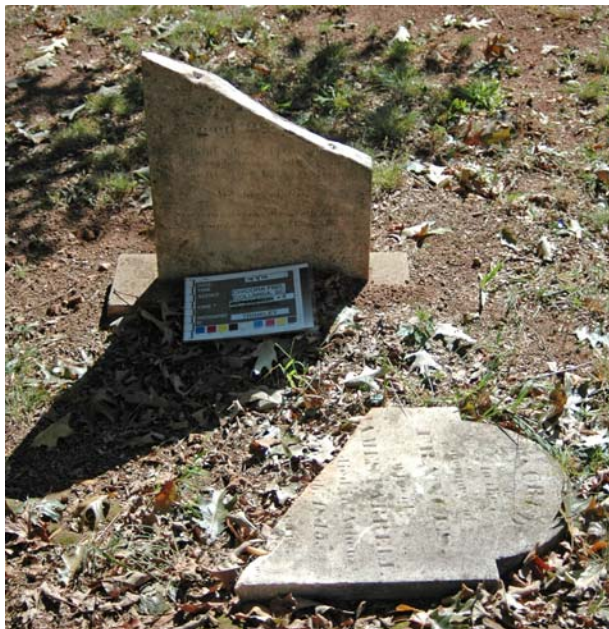
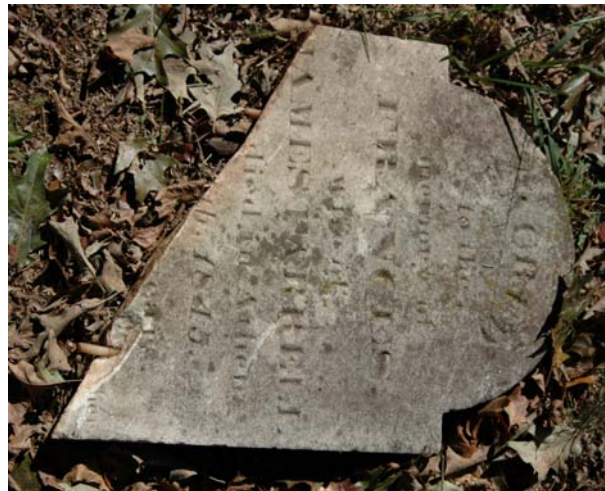
Old Athens Cemetery, Athens, GA
Monument Treatment Proposal

Position: ☐ fallen ☒ tilted ☐ unstable ☐ unattached/loose ☐ missing

Failed/Old Treatments: ☐ metal ☐ adhesives/coatings ☐ mortar ☒ other: stone set in concrete

Position: ☒ reset/level in ground ☐ reset/level to existing base ☐ construct new base ☐ resquare
☐ possible new base required ☐ stabilize foundation ☐ reset with 0:1:3 mix ☐ reset with compound

Failed Treatments: ☐ drill/grind ☒ hand tools ☐ solvents ☒ other: remove concrete; reset in pea gravel

Cost: \$150

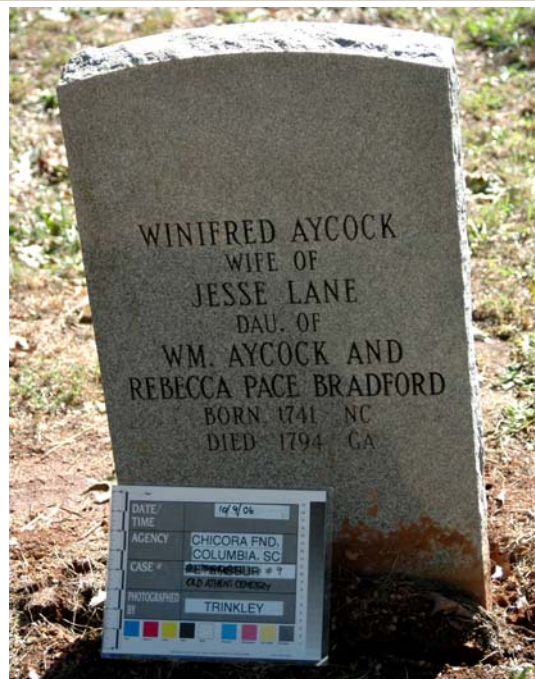
Old Athens Cemetery, Athens, GA
Monument Treatment Proposal

Position: ☐ fallen ☐ tilted ☒ unstable ☐ unattached/loose ☐ missing

Deterioration: ☒ broken ☐ cracked ☐ losses ☐ flaking/sugaring ☐ ferrous pins ☐ brass pins
☐ delamination/detachment ☐ spalling ☐ missing fragments ☐ other:

Soiling: ☒ biological ☒ staining ☐ efflorescence ☐ other:

Position: ☒ reset/level in ground ☐ reset/level to existing base ☒ construct new base ☐ resquare
☐ possible new base required ☐ stabilize foundation ☒ reset with 0:1:3 mix ☐ reset with compound

Treatment: ☐ core drill ☒ drill and pin ☐ simple adhesive repair ☐ injection grout ☐ replace bricks
☐ mortar ☐ repoint ☒ other: infill with Jahn M120 Marble Mortar

Cost: \$850

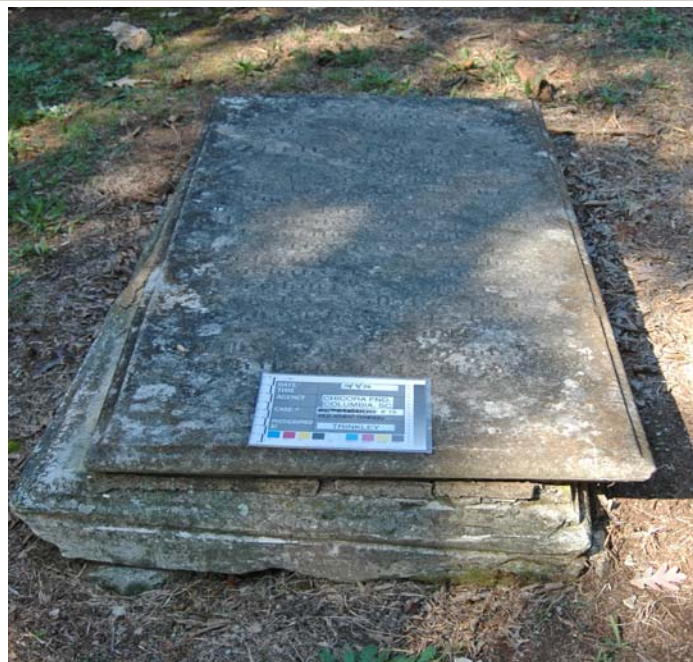
Old Athens Cemetery, Athens, GA
Monument Treatment Proposal

Material: ☒ marble ☐ granite ☐ brick ☒ other: local stone foundation

Type: ☐ headstone ☐ footstone ☐ die on base ☐ tab in socket ☐ box ☒ other: ledger on foundation

Position: ☐ fallen ☐ tilted ☐ unstable ☒ unattached/loose ☐ missing

Deterioration: ☐ broken ☐ cracked ☐ losses ☐ flaking/sugaring ☐ ferrous pins ☐ brass pins
☐ delamination/detachment ☒ spalling ☐ missing fragments ☐ other:

Soiling: ☒ biological ☒ staining ☐ efflorescence ☐ other:

Position: ☐ reset/level in ground ☒ reset/level to existing base ☐ construct new base ☒ resquare
☐ possible new base required ☐ stabilize foundation ☐ reset with 0:1:3 mix ☐ reset with compound

Cost: \$450

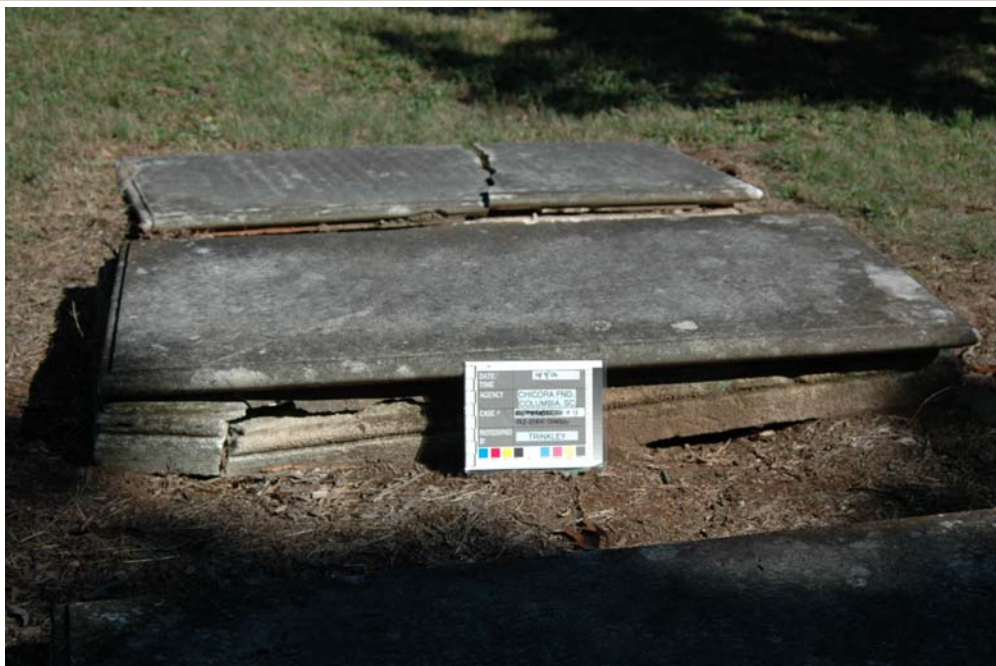
Old Athens Cemetery, Athens, GA
Monument Treatment Proposal

Material: ☒ marble ☐ granite ☐ brick ☒ other: local stone foundation

Type: ☐ headstone ☐ footstone ☐ die on base ☐ tab in socket ☐ box ☒ other: ledger on foundation

Position: ☐ fallen ☐ tilted ☒ unstable ☒ unattached/loose ☐ missing

Soiling: ☒ biological ☒ staining ☐ efflorescence ☐ other:

Cost: \$850

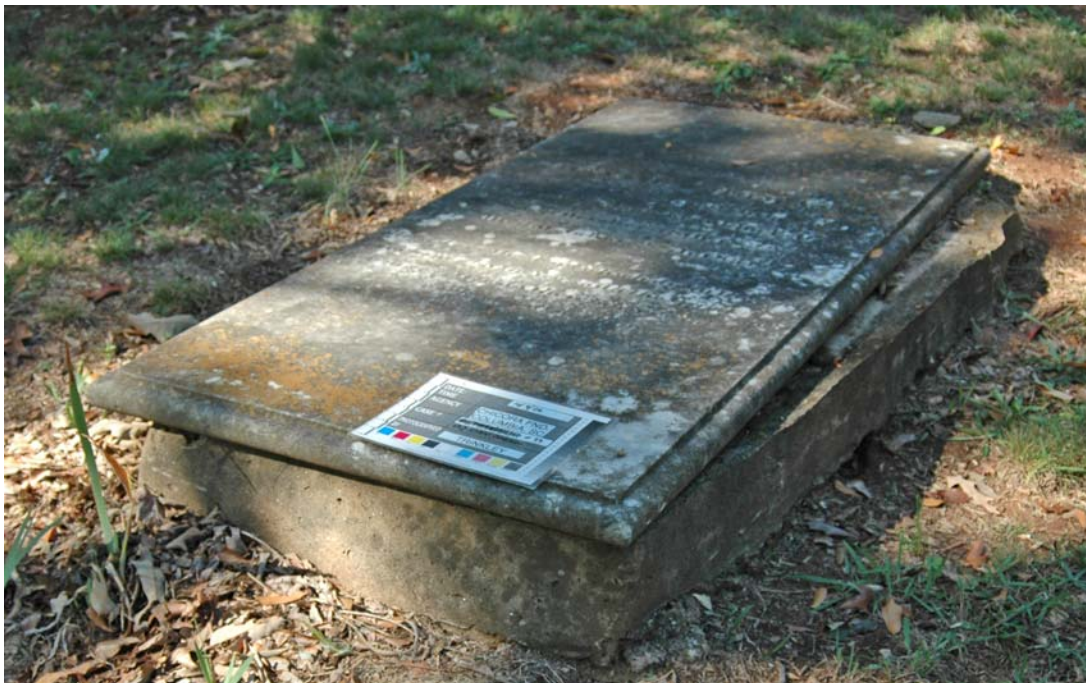
Existing Condition

Position: ☒ fallen ☐ tilted ☐ unstable ☐ unattached/loose ☐ missing

Deterioration: ☒ broken ☐ cracked ☐ losses ☐ flaking/sugaring ☐ ferrous pins ☐ brass pins
☐ delamination/detachment ☐ spalling ☒ missing fragments ☐ other:

Soiling: ☒ biological ☒ staining ☐ efflorescence ☐ other:

Position: ☒ reset/level in ground ☐ reset/level to existing base ☐ construct new base ☐ resquare
☐ possible new base required ☐ stabilize foundation ☐ reset with 0:1:3 mix ☐ reset with compound

Treatment: ☐ core drill ☒ drill and pin ☐ simple adhesive repair ☐ injection grout ☐ replace bricks
☐ mortar ☐ repoint ☒ other: infill with Jahn M120 Marble Mortar

Cost: \$800

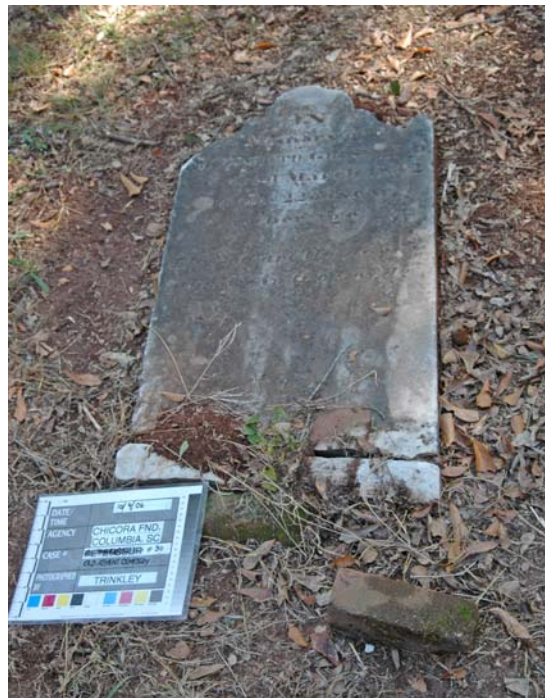
Existing Condition

Position: ☐ fallen ☐ tilted ☐ unstable ☒ unattached/loose ☐ missing

Deterioration: ☐ broken ☐ cracked ☐ losses ☐ flaking/sugaring ☐ ferrous pins ☐ brass pins
☐ delamination/detachment ☐ spalling ☒ missing fragments ☐ other:

Soiling: ☒ biological ☒ staining ☐ efflorescence ☐ other:

Position: ☐ reset/level in ground ☒ reset/level to existing base ☐ construct new base ☒ resquare
☐ possible new base required ☐ stabilize foundation ☒ reset with 0:1:3 mix ☐ reset with compound

Treatment: ☐ core drill ☐ drill and pin ☐ simple adhesive repair ☐ injection grout ☐ replace bricks
☐ mortar ☐ repoint ☐ other:

Cost: \$300

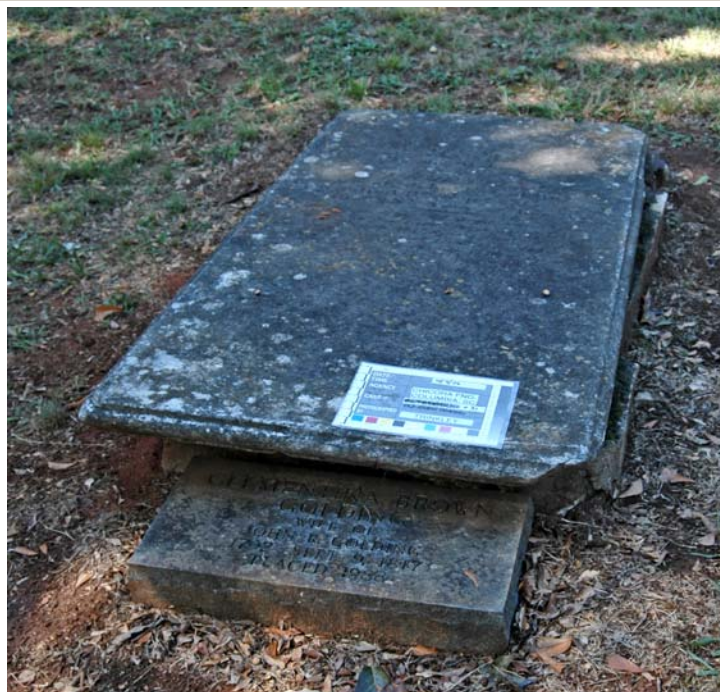
Position: ☐ fallen ☐ tilted ☒ unstable ☒ unattached/loose ☐ missing

Deterioration: ☐ broken ☐ cracked ☐ losses ☐ flaking/sugaring ☐ ferrous pins ☐ brass pins
☐ delamination/detachment ☐ spalling ☒ missing fragments ☐ other:

Soiling: ☒ biological ☒ staining ☐ efflorescence ☐ other:

Position: ☐ reset/level in ground ☒ reset/level to existing base ☐ construct new base ☐ resquare
☐ possible new base required ☐ stabilize foundation ☐ reset with 0:1:3 mix ☐ reset with compound

Treatment: ☐ core drill ☐ drill and pin ☐ simple adhesive repair ☐ injection grout ☐ replace bricks
☐ mortar ☐ repoint ☒ other: replace two missing corners that serve to tie together side and end panels

Cost: \$1850

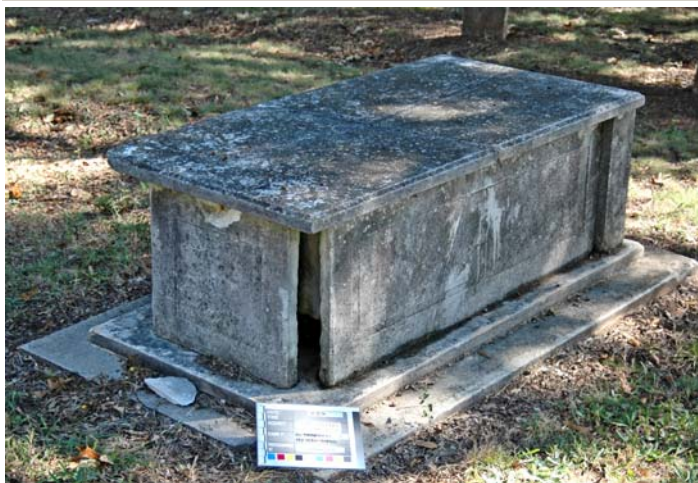
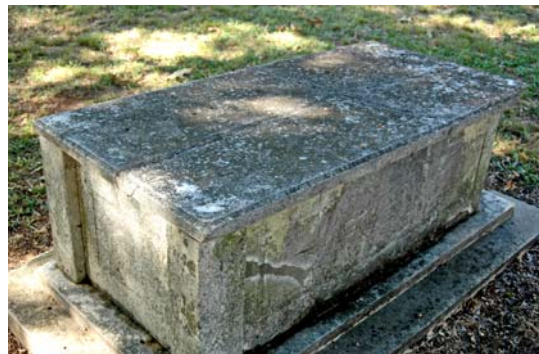
Existing Condition

Position: ☐ fallen ☐ tilted ☐ unstable ☒ unattached/loose ☐ missing

Deterioration: ☒ broken ☐ cracked ☐ losses ☐ flaking/sugaring ☐ ferrous pins ☐ brass pins
☐ delamination/detachment ☐ spalling ☐ missing fragments ☐ other:

Soiling: ☒ biological ☒ staining ☐ efflorescence ☐ other:

Position: ☐ reset/level in ground ☒ reset/level to existing base ☐ construct new base ☐ resquare
☐ possible new base required ☐ stabilize foundation ☒ reset with 0:1:3 mix ☐ reset with compound

Treatment: ☐ core drill ☒ drill and pin ☐ simple adhesive repair ☐ injection grout ☐ replace bricks
☐ mortar ☐ repoint ☒ other: infill with Jahn M120 Marble Mortar

Cost: \$900

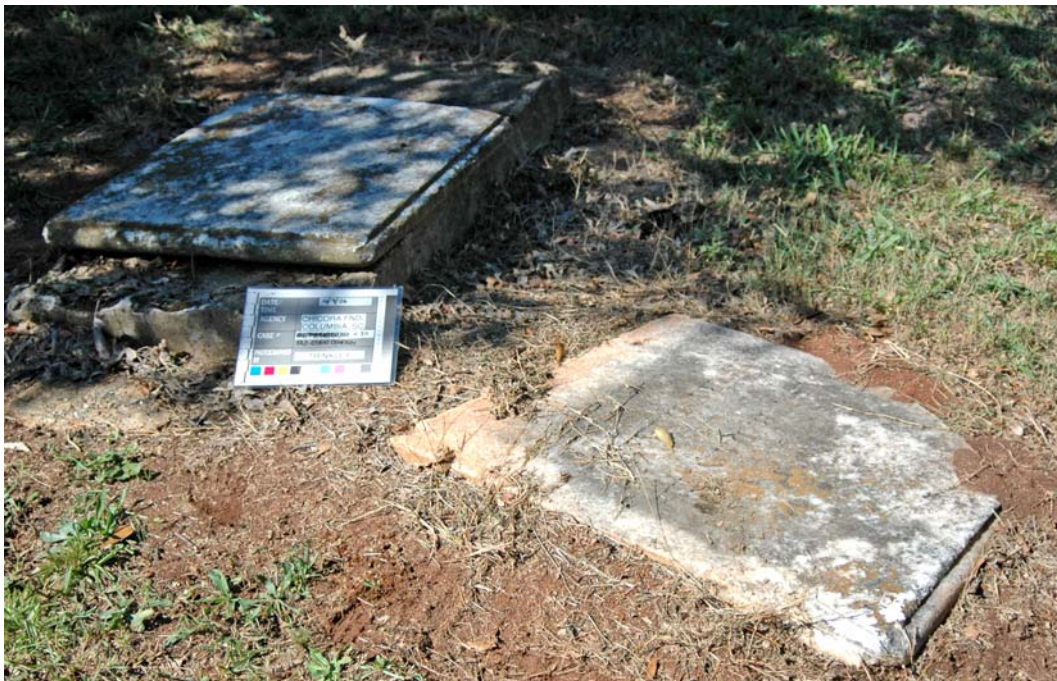
Existing Condition

Position: ☐ fallen ☐ tilted ☐ unstable ☒ unattached/loose ☐ missing

Deterioration: ☒ broken ☐ cracked ☐ losses ☐ flaking/sugaring ☐ ferrous pins ☐ brass pins
☐ delamination/detachment ☐ spalling ☒ missing fragments ☐ other:

Failed/Old Treatments: ☐ metal ☐ adhesives/coatings ☐ mortar ☒ other: nylon pins

Soiling: ☒ biological ☒ staining ☐ efflorescence ☐ other:

Position: ☐ reset/level in ground ☒ reset/level to existing base ☐ construct new base ☐ resquare
☐ possible new base required ☐ stabilize foundation ☒ reset with 0:1:3 mix ☐ reset with compound

Failed Treatments: ☐ drill/grind ☐ hand tools ☐ solvents ☒ other: remove existing pins

Treatment: ☐ core drill ☒ drill and pin ☐ simple adhesive repair ☐ injection grout ☐ replace bricks
☐ mortar ☐ repoint ☒ other: may be necessary to infill box in order to support repair; infill ledger with Jahn M120 Marble Mortar

Cost: \$1200

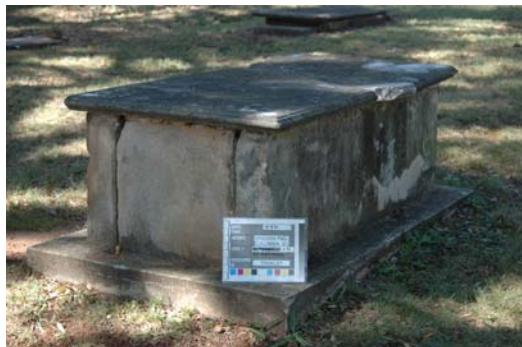
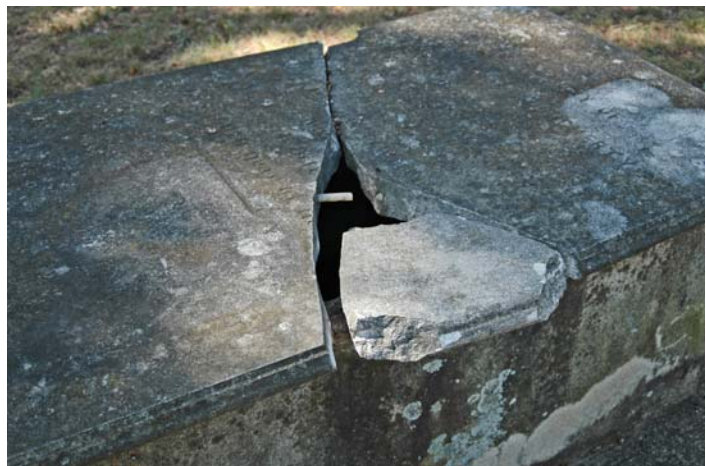
Existing Condition

Position: ☐ fallen ☐ tilted ☐ unstable ☒ unattached/loose ☐ missing

Deterioration: ☒ broken ☐ cracked ☐ losses ☐ flaking/sugaring ☐ ferrous pins ☐ brass pins
☐ delamination/detachment ☐ spalling ☒ missing fragments ☐ other:

Soiling: ☒ biological ☒ staining ☐ efflorescence ☐ other:

Position: ☐ reset/level in ground ☒ reset/level to existing base ☐ construct new base ☐ resquare
☐ possible new base required ☐ stabilize foundation ☒ reset with 0:1:3 mix ☐ reset with compound

Treatment: ☐ core drill ☒ drill and pin ☐ simple adhesive repair ☐ injection grout ☐ replace bricks
☐ mortar ☐ repoint ☒ other: infill with Jahn M120 Marble Mortar; injection grout may be necessary

Cost: \$1100
